NASA TECHNICAL  
MEMORANDUM

NASA TM X-64814

MSFC SKYLAB MISSION REPORT—SATURN WORKSHOP

Skylab Program Office

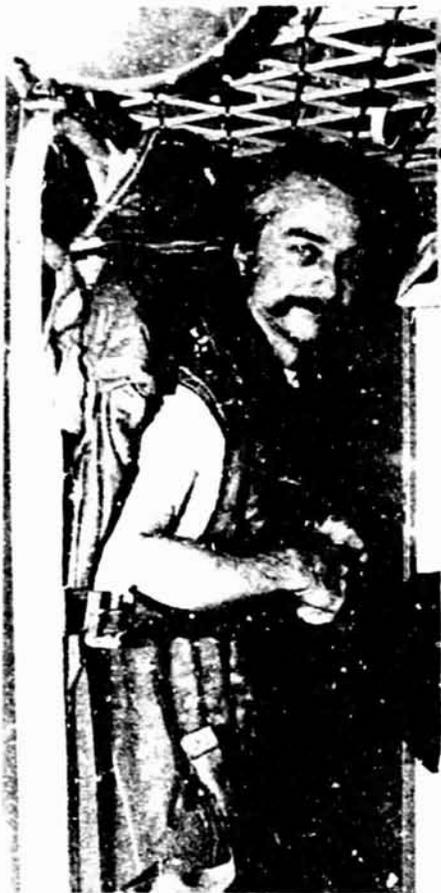
Figure 10-26.- Sleep area and restraint.

Sleep Restraints.- These adjustable restraints (fig. 10-26) permit each crewman to assume a sleeping position of his choice yet provide complete body restraint. They also allow reasonably rapid egress under emergency conditions. The sleep restraint consists of a welded tubular frame, a thermal back assembly, a comfort restraint, top and bottom blankets, a headrest and cover, and body straps. These components are constructed of a variety of fabric materials designed to provide the crewman a range of thermal comfort and body restraint options. The frame, thermal back assembly, and headrest are used by the crewmen throughout the mission. The remaining items are changed periodically. There are 27 additional comfort restraints, top blankets, and headrest covers stowed in the sleep compartment, providing a change every 14 days for each sleep restraint. There are 12 spare bottom blankets and large body straps and 24 small body straps to provide for a changeout every 28 days. One large and two small body straps are required for each sleep restraint.

There were no significant discrepancies with any of the sleep restraint equipment, and the crew expressed general satisfaction. The planned changeout of bedding was probably more frequent than necessary, and a reduction would improve stowage provisions and save time. The crew specifically requested that nomenclature be provided on the blankets, headrest inserts, and body straps for identification and orientation. Several crewmen suggested additional elastic straps with adjustment capability. One crewman requested an easier means of ingress and egress, although this did not appear to be a problem for the majority. On occasions, the sleep compartment was used for temporary stowage during the day, and the sleep restraint proved useful for handling bulky items such as urine bags and supply modules.

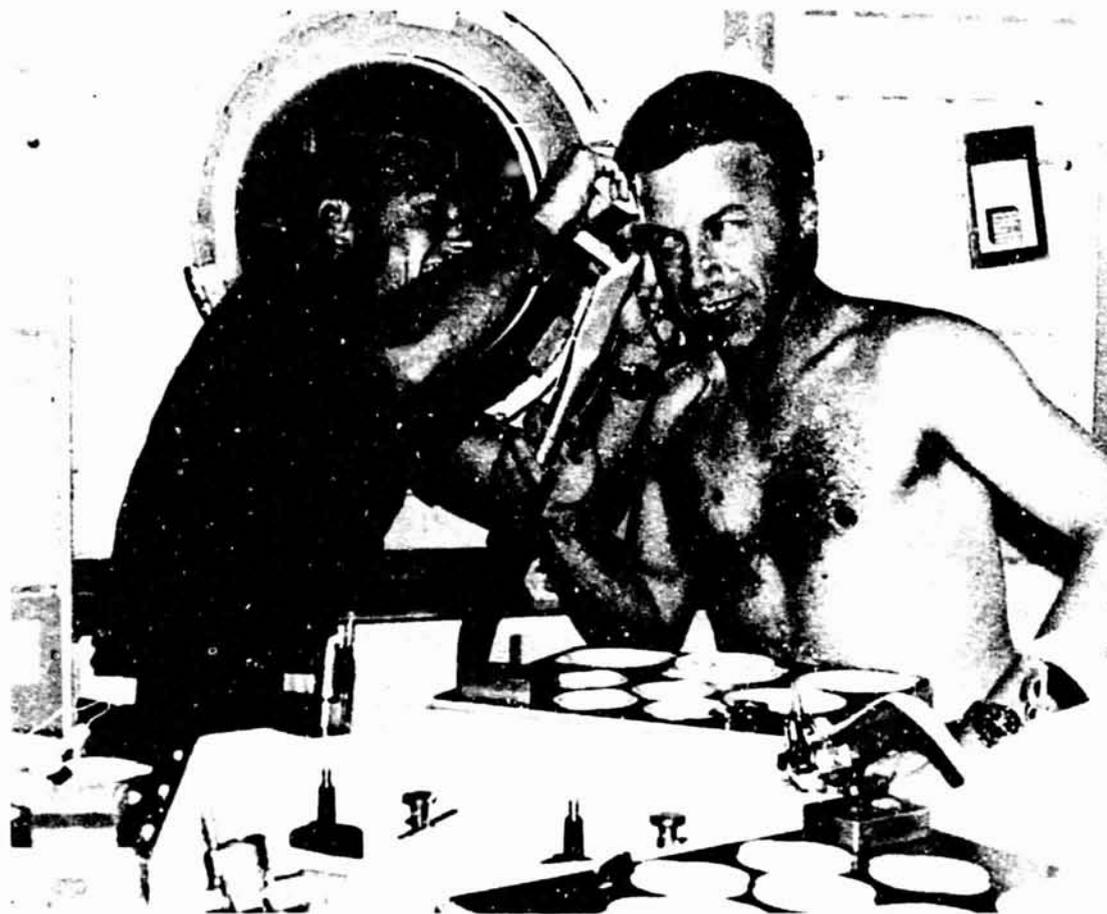
Figure 10-33.- Use of vacuum cleaner to collect hair clippings.

The crew reported that the vacuum cleaner worked satisfactorily; however, they all recommended that it have more suction. It was used primarily to clean the air inlet and debris screens on the mixing chamber and waste management compartment exhaust fan. The crew felt that the screens should be vacuumed about every 3 days instead of weekly as scheduled. The unit was used about 15 minutes on each occasion, and a bag change required 5 to 10 minutes. The vacuum cleaner was also used to collect hair, as shown in figure 10-33. Although designed for wet debris, it was not used for this during the mission. The usage rate of debris bags was lower than expected, with approximately 25 bags used.

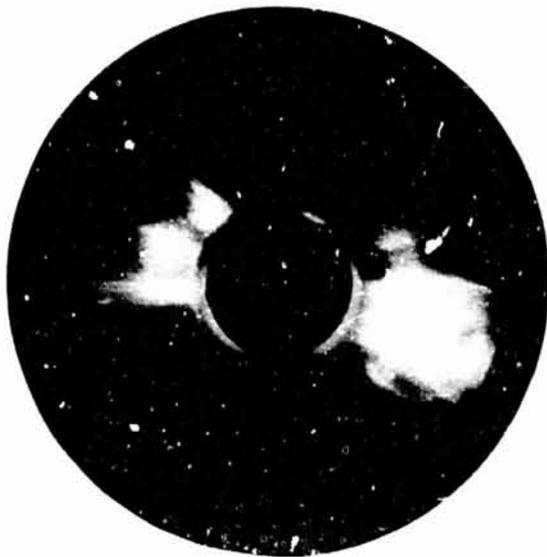
Figure 12-5.- White light corona-graph filmed corona detail.

During the mission, five film cameras containing 35-millimeter Kodak Special 026-02 thin base film were used to obtain a total of 35,918 frames. Evaluation of developed film indicated that exceptionally high quality photographic data were obtained, with considerable coronal detail visible on the film. The photographs brought out a wealth of detail on the structure of the corona. The coronal structure was enhanced by the instrument's vignetting feature, which allowed more light to be viewed from the outer corona than from the inner corona. Together with the three lengths of exposure (3, 9, and 27 seconds), this vignetting served to extend the effective photographic dynamic range of the instrument, permitting very faint outer-coronal detail observation on long exposures, and inner-coronal detail without blooming on short exposures. As an example, figure 12-5, a photograph in unpolarized light, is one of a sequence of 144 frames taken of an eruptive prominence, moving outward from the solar limb into the corona. The loop structures are material, moving outward, with a velocity of approximately 450 km/sec. This rare event was observed for approximately 0.5 hour.

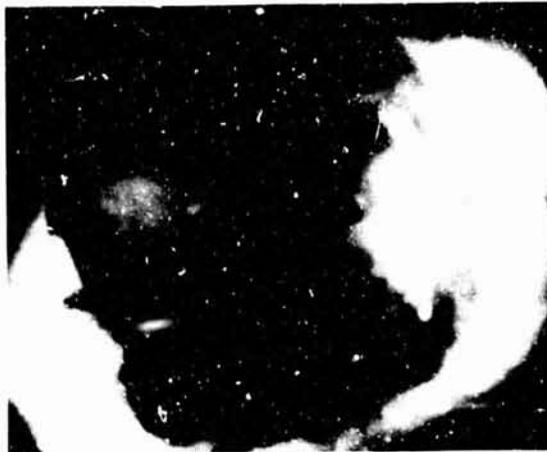
Figure 12-7.- Experiment S054 X-ray photograph of the solar disk.

Developed film was of excellent optical quality, indicating that alignment of the telescope optical elements was maintained. Spatial resolution was better than 2 arc-sec, which compares favorably to the design requirement of 3 arc-sec. Spectral resolution was 50 at 7 angstroms with the design requirement being 30 at 7 angstroms. No noticeable jitter or drift was evident on the photographs except as anticipated, when the solar observatory experiment pointing control was disabled. Figure 12-7 is a photograph of the solar disk. Dispersed images from 3 to 60 angstroms were recorded during the second and third manned periods.

No dispersed images were obtained during the first manned periods since the X-ray transmission grating was not used.

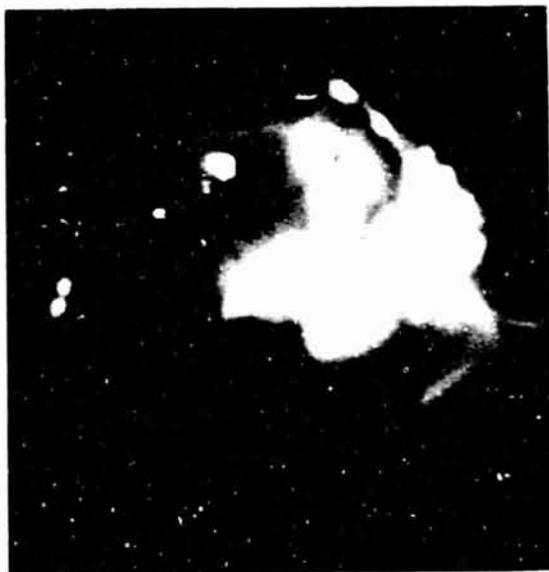
The overall X-ray image quality of the film was good and indicated stable optical performance of the telescope. Figure 12-12 is a representative photograph taken by the camera. The X-ray event analyzer obtained 1174 hours of spectral data and was the first instrument to detect the major solar flare that occurred on Day 33. During the flare, the X-ray flux through the beryllium filter (7.25 angstroms), rose to 500,000 counts per second in approximately 5 minutes.

Figure 12-12.- Experiment S056  
X-ray solar activity.

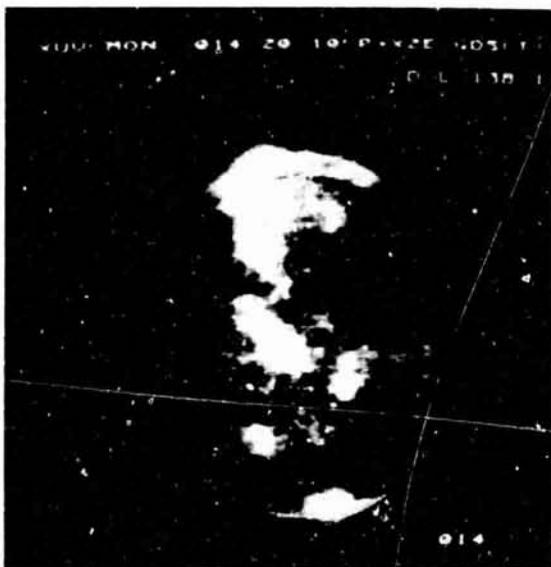
the disk (corona) exposed for 2.5 seconds in the 2300- to 2440-angstrom wavelength band. Representative photographs of an extreme ultraviolet monitor downlink transmission, obtained on Days 27 and 246, are shown in figure 12-17. The significant features seen from these photographs include high prominences on each limb and light areas in the center, where there is extreme ultraviolet activity.

Figure 12-17.- Experiment S082B extreme ultraviolet monitor downlink photograph.

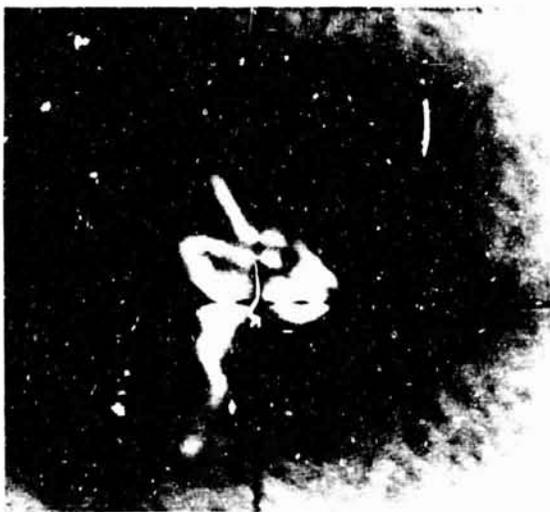
Figure 12-21.- Hydrogen alpha 1 television.

Evaluation of the flight film indicated excellent optical quality. Figures 12-19 and 12-20 are examples of the photographs on Day 33 showing the solar disk in fine detail. Both vidicon cameras operated normally, displaying real-time solar detail to the crew on the control console video monitors, and providing downlinked television images for use in solar observation planning. The television images remained stable except for some degradation evident on hydrogen alpha 1 during the last month of the mission. Figures 12-21 and 12-22 are photographs of the downlinked television images.

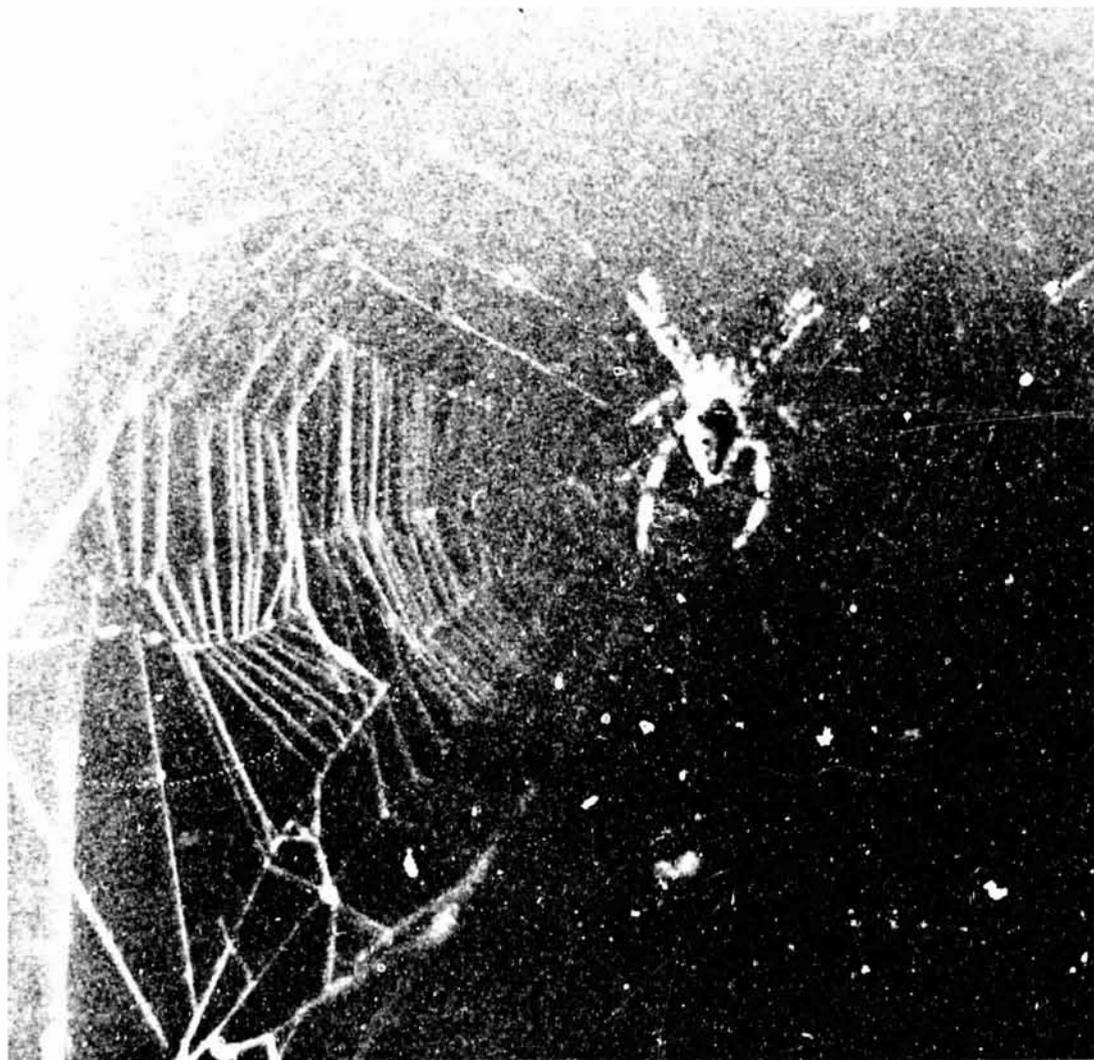
The basic requirement is to obtain a maximum of 400 feet of motion picture film of the web spinning process and three still photographs of each of three webs. The significant constraints are to deploy the experiment no later than 3 days after launch of the command and service module and to operate it for a maximum of 20 days. The experiment hardware is transferred to the workshop forward dome area. The motion picture camera is loaded and installed on the camera mount. Proper automatic camera actuator operation is verified, and the spider is deployed. Crew observations are made during the deployment and once a day hereafter. When a web is completed, the still camera replaces the motion picture camera for photography of the web as shown in figure 12-62.

Figure 12-62.- Spider and inflight web.
